TECHNICAL MANUSCRIPT 417

SHIPPING CONTAINERS
FOR ONE GALLON OR LESS
OF ETIOLOGIC AGENT TESTED
IN CRASH OF C-119 AIRCRAFT

Agent Control Division
INDUSTRIAL HEALTH AND SAFETY OFFICE

December 1967

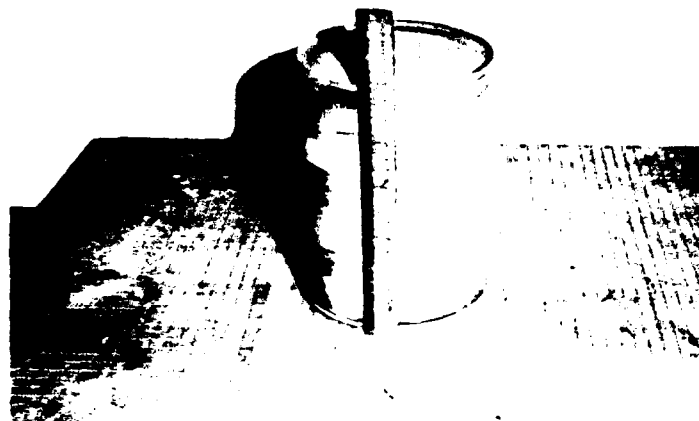
Figure 3. Telescopic, Asphalt Impregnated,
Spiral Wound Fiber Individual
Shipping Container Used in Packages
A, B, and C.

Each of three No. 3 tin cans (can size 404-700, 4.25 inches diameter x 7 inches high), capacity 51.7 oz, at 68 F contained 1,400 ml of E. coli liquid suspension. Each was crimp-sealed, wrapped with absorbent cotton (approximately 8 oz), and then placed in a No. 12 1-gallon crimp-sealed tin can (can size 603-812). This assembly was placed in a spirally wound telescopic fiber container (metal top and bottom, cardboard asphalt impregnated sides), Military Specification MIL C-3955A, 16 February 1960. Outer dimensions were 7 1/8 inches diameter by 9 5/16 inches high. Absorbent cotton then was forced into the void (approximately 0.25 inch) between the tin can and fiber container. The fiber container was sealed with 1-inch wide tape at the top-to-bottom joint (Fig. 1 through 3). This fiber container is designated under 42 CFR as the "individual shipping container."

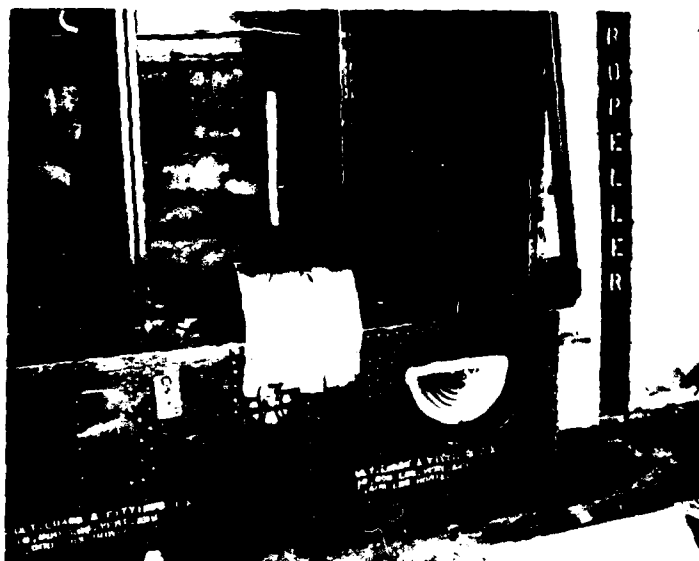
Figure 7. Package A Secured in Aircraft.
1,400-ml container in horizontal
position.

The four containers were located in the cargo area of the aircraft adjacent to each corner of the principal experimental container (Fig. 6). One of the 1,400-ml containers (B package) was placed in ice inside a 31-inch long, 14-inch wide, 16-inch high insulated aluminum chest (normal manner for shipment of agent in this size container). All four containers were located as shown in Figure 6 and secured as shown in Figures 7 through 10.

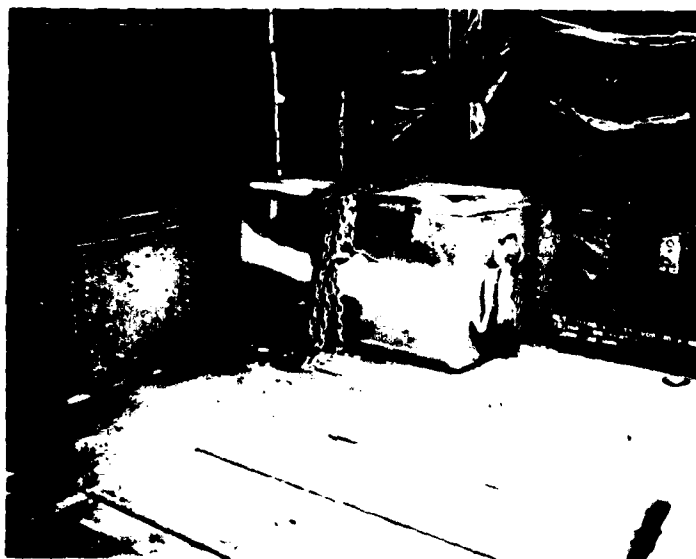
Figure 8. Package B Secured in Aircraft.
1,400-ml container in ice inside
aluminum ice chest.

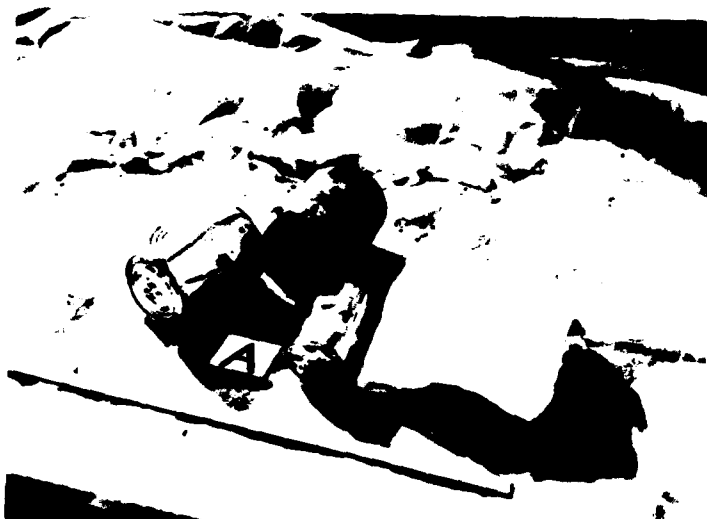
Figure 11. Package A after the Crash.
The No. 12 can was removed by hand
from the fiber container and then
opened to show the condition of
the No. 3 can (no leakage).

Following the crash of the C-119, all four containers were thrown clear of the wreckage at a distance from 2 to approximately 200 feet. Package A was beneath the wings. Its metal bottom was open, but otherwise the package was intact. The aluminum ice chest (package B) was thrown out of the aircraft immediately forward of the fuselage and crushed. However, the individual shipping container (fiberboard) had been ejected from the ice chest and lay approximately 1 foot away with its metal bottom that was torn loose. Otherwise this container was intact. The individual shipping container of package C was separated from its double tin can assembly and lay approximately 20 feet away. The metal top was torn from the fiber sides and was about 7 feet from the other part. The nested metal cans were intact except for a tear (approximately 1 inch) in the No. 12 can. The PEMA container remained secured to the cylindrical camera box with its sides crushed from the force exerted on its tiedown chain. The outer steel drum and the inner steel drum were wedged together, but neither was ruptured. This container was found on top of the embankment approximately 200 feet from the aircraft impact area. Damage to the four shipping containers is shown in Figures 11 through 14.

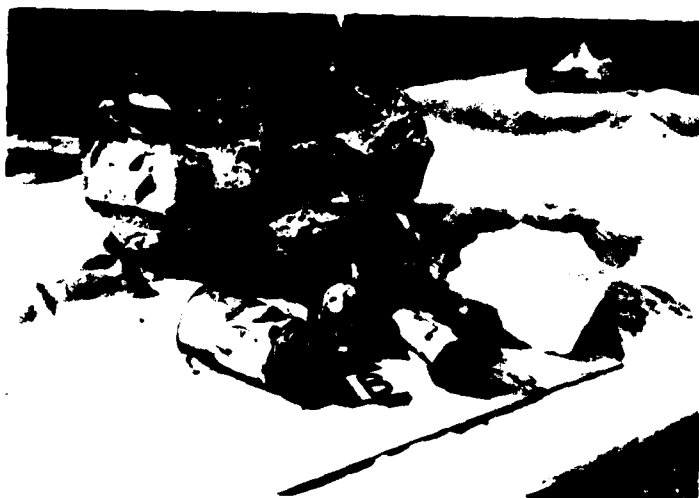
Figure 12. Package B after the Crash.
The package has been disassembled to
show that the metal bottom of the
fiberboard container was torn loose
and that the No. 12 and No. 3 cans
were dented but intact (no leakage).
Ice chest was crushed.

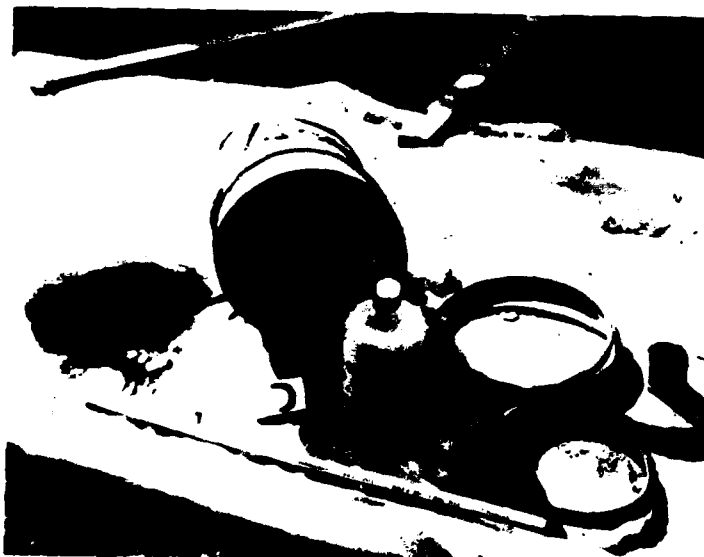
Figure 14. Package D (the PEMA Container) after
the Crash.
Disassembled: left, vermiculite;
center, nested steel drums; right,
1-gallon plastic bottle (no leakage).
